SPECIFICATIONS

DIMENSIONS AND WEIGHTS

AUXILIARY FUNCTION VALVE

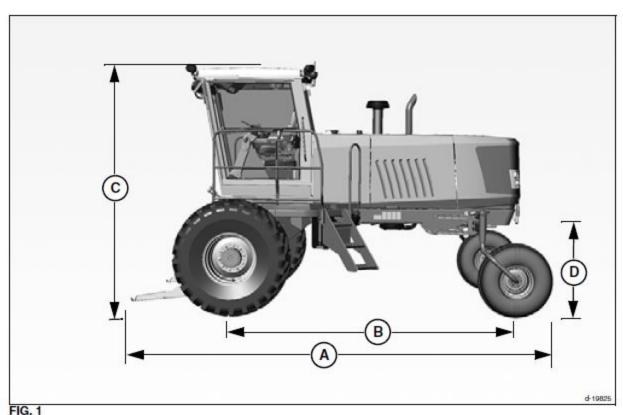
FIG. 1: Side view with 620/75R26 tires front tires and 16.5-16.1 rear tires

Ref	Description	Dimension
Α	Length, tractor only	5323 mm (209.6 in)
	Length, total with single conditioner rotary header	6917 mm (272.3 in)
В	Wheel base	3843 mm (151.3 in)
С	Height	3450 mm (135.8 in)
D	Clearance under frame	1075 mm (42.3 in)
